NATIONAL ADVISORY COMMITTEE FOR AERONAUTICS

TIDEWATER AND WEATHER-EXPOSURE TESTS ON METALS

USED IN AIRCRAFT - II

TECHNICAL NOTE No. 842

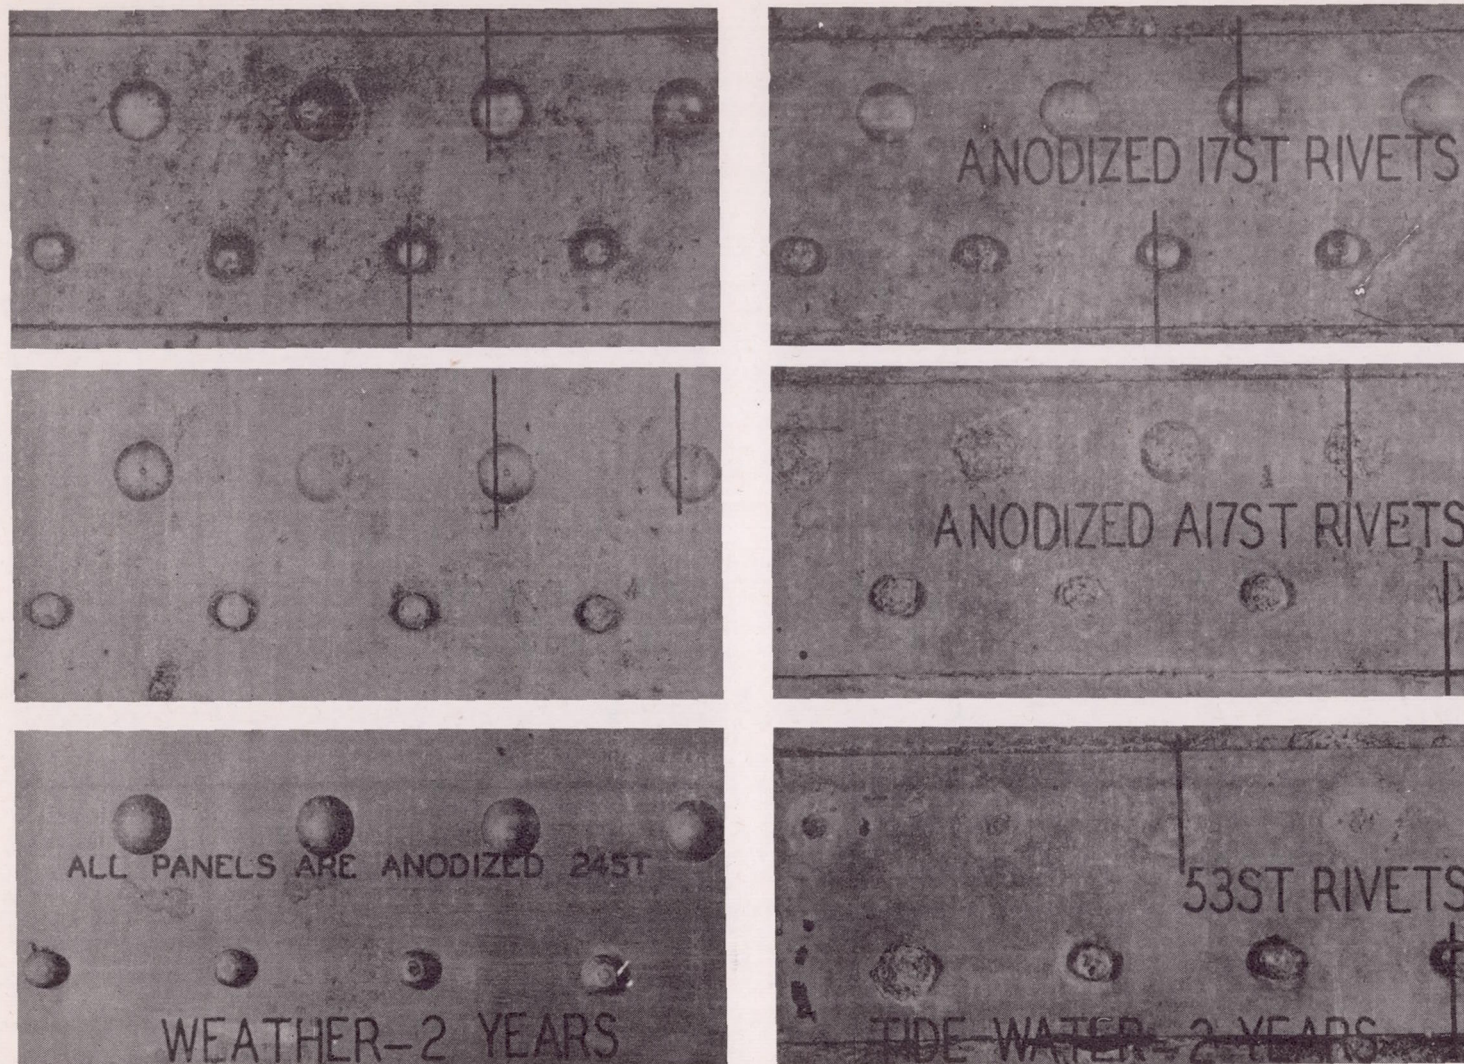
The attack on the 53ST and the anodized Al7ST rivets on 24ST sheet was but little worse after the second than after the first year of exposure. The corrosion on rivets treated with sealed Alumilite coatings was almost as severe as that on rivets anodized in the chromic-acid electrolyte. Sufficient disintegration had occurred during the first year to make it evident that both alloys were anodic with respect to 24ST. The photomicrographs (fig. 4) disclose the severity of the attack on the rivet heads and reveal no corrosion on portions of the 24ST sheet adjacent to, or in contact with, the rivets. The attack on the 53ST rivets was in part intercrystalline, and corrosion was occasionally noted on the shanks of both 53ST and anodized Al7ST rivets.

Figure 2.- Rivets used on 24ST alloy panels exposed for 2 years. Note the advanced disintegration of the 53ST and the anodized A17ST rivets exposed to the tidewater as compared with those exposed to the weather, and the relative absence of attack on the anodized 17ST rivets. In this, and all similar photographs that follow, the large letters at the right apply to the entire horizontal rows, while those at the tops or bottoms apply to the entire vertical rows. x 1 (4 and 6).

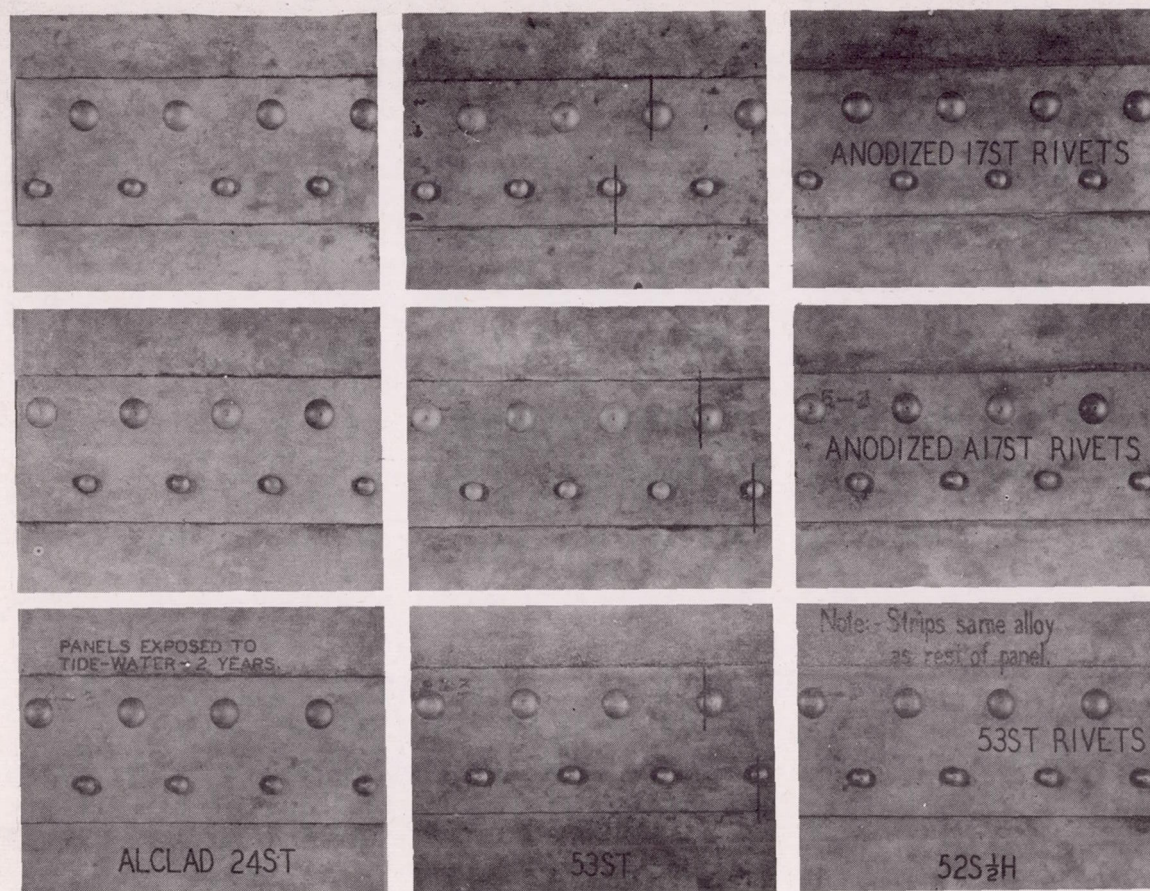
The microscopic examinations confirmed the practical absence of corrosive attack on either the rivets or the sheets where any of the three kinds of rivet were used to join Alclad 24ST, 52S- $\frac{1}{2}$ H, or 53ST (fig. 4) sheet. Such corrosion as occurred seldom exceeded 0.002 inch in depth and was of the pitting type on all the alloys.

Figure 3.- Rivets used on panels of Alclad 24ST, 53ST, and 52S- $\frac{1}{2}$ H alloys exposed to tidewater. Neither the rivets nor the sheets are corroded. $\times 1/2$ (5).

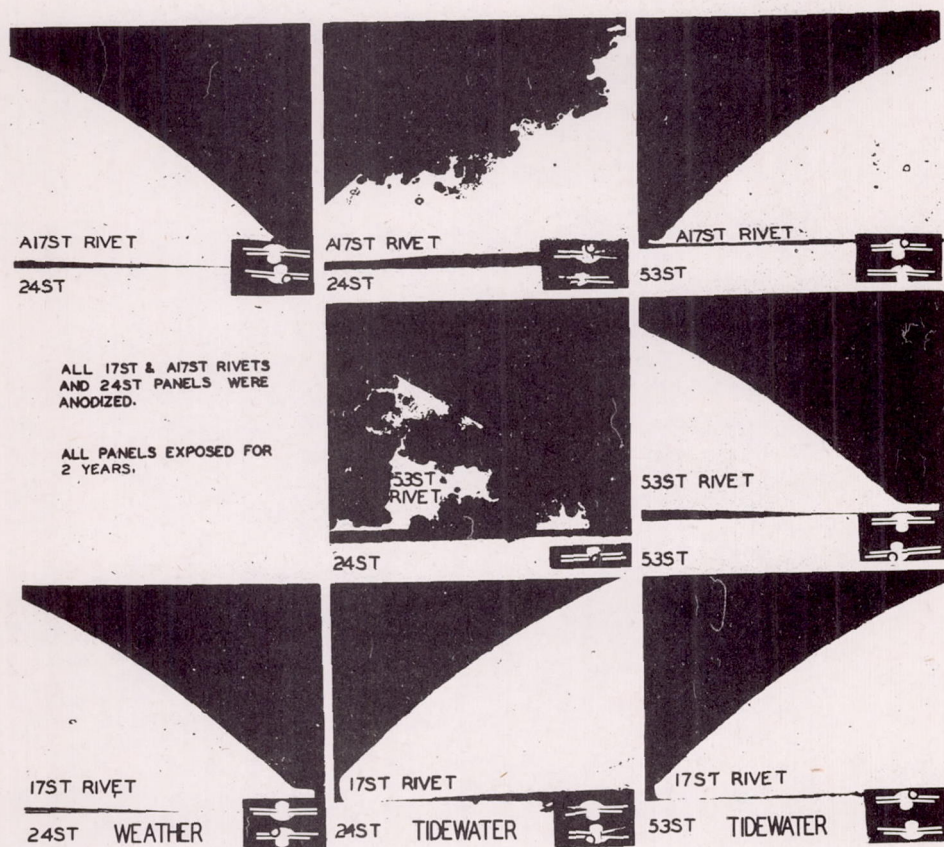
Figure 4.- Corrosion on rivet heads and 53ST and anodized 24ST sheets. Attack was especially severe on 53ST and anodized A17ST rivets joined to 24ST sheet and exposed to tidewater. Photomicrographs, $\times 25$; cross sections (in black rectangles), $\times 1/2$.

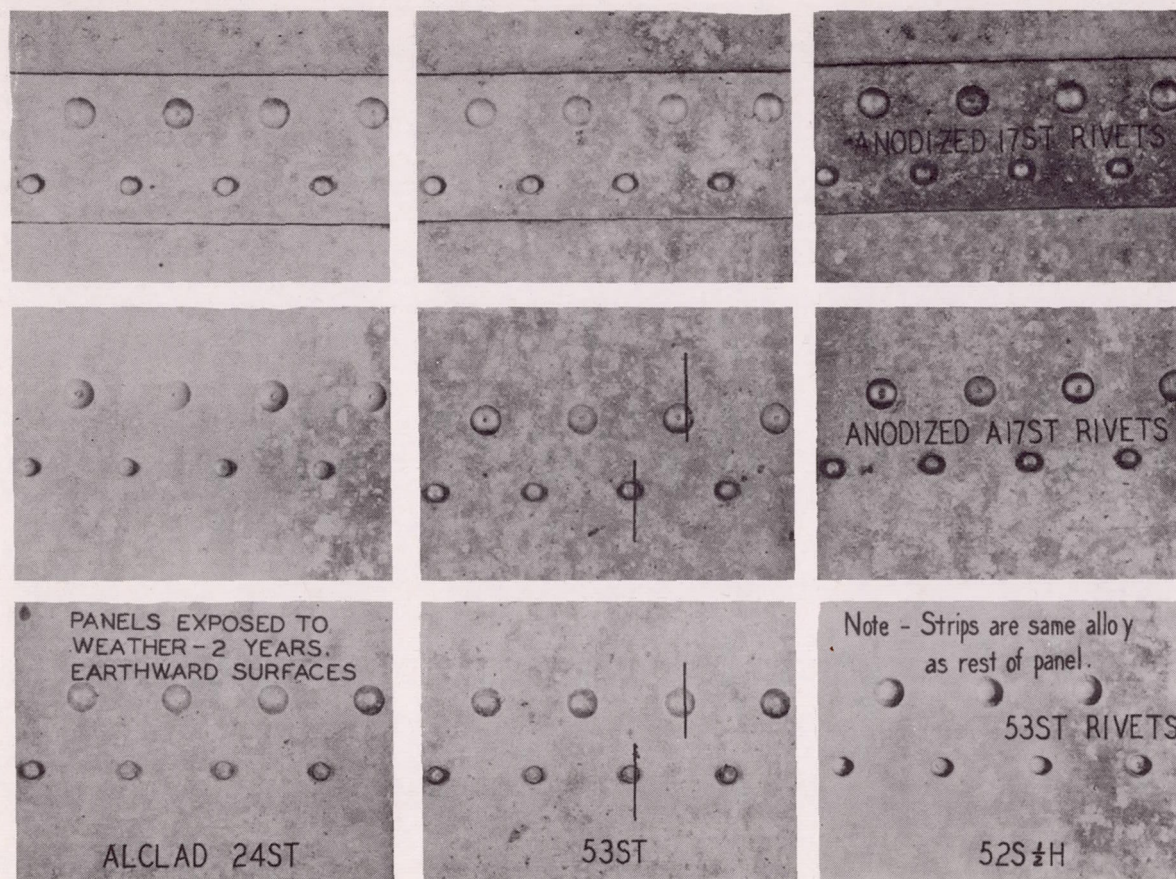
were noted on most of the rivet heads, as well as on the sheet alloys, but were least in evidence on the anodized 24ST sheet. At the end of the second year the areas were slightly larger, somewhat more numerous, and the deposits of corrosion products were somewhat heavier (fig. 5), and there was considerably more attack on the anodized 24ST sheets (fig. 2). At the end of the second year, also, corrosion on the 53ST and the anodized Al7ST rivets joined to anodized 24ST sheet was noticeably more advanced than on any of the other rivets (fig. 2). The microscopic examinations revealed that the attack on the Al7ST and 53ST rivets was deepest (0.004 and 0.009 in., respectively) at the base of the heads near the circumference, where water would tend to be retained longest and permit cell reactions. Scattered areas of attack on the 24ST sheet seldom exceeded 0.002 inch in depth. Severe attack (0.01 in. deep) was also found on 53ST rivets on 53ST sheets. On the Alclad 24ST and 53ST sheets slight attack was noted adjacent to or under the anodized Al7ST and 17ST rivet heads. The restricted volume of electrolyte occasionally present at such areas was perhaps responsible for such attack for, in the tidewater tests, where the water covered the entire panel, the phenomenon was not noted. Although corrosive attack was more prevalent on all the rivets and panels exposed to the weather than on the corresponding specimens exposed to tidewater, its depth seldom exceeded 0.003 inch. The corrosion on the 53ST alloy in the weather-exposure tests, as in the tidewater tests, was partly intercrystalline in character.

Figure 5.- Rivets used on panels of Alclad 24ST, 53ST, and 52S- $\frac{1}{2}$ H alloys exposed to the weather. Attack on both rivets and sheet was, in general more severe than in the tidewater tests.
x 1/2 (6).

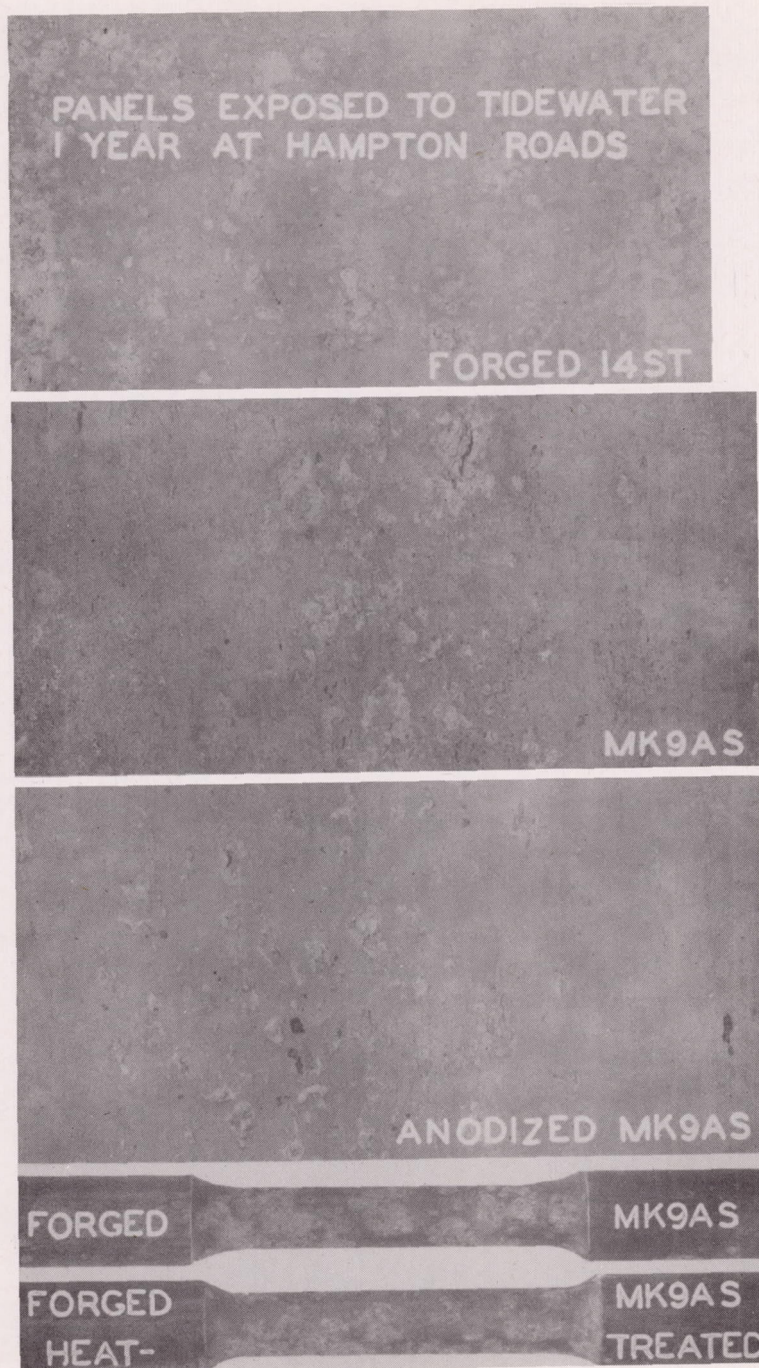
Unriveted aluminum-alloy panels.— The forged 14ST panels, not anodically treated, were the most severely attacked of all the aluminum alloys, both in the tidewater and weather-exposure tests (fig. 6). The corrosion was predominantly intercrystalline and attained a depth of 0.015 inch in tidewater and of 0.01 inch in the weather after 2 years. These panels were solution heat-treated in air at approximately 940° F, given a quench in an aqueous solution (not in air, as erroneously stated in table II of reference 1), and aged 10 hours at 340° F.

The Major metal sheets (fig. 6), anodized and unanodized, corroded in a fashion quite similar to the 14ST alloy. The attack was largely intercrystalline and the unanodized sheet panels 0.060 inch thick were penetrated in spots after 6 months in the tidewater. The specimens exposed as forged and heat-treated bars, 0.575 inch diameter, had an initial (uncorroded) ultimate tensile strength

Figure 6.- Forged 14ST and Major metal (MK9AS) panels exposed to tide-water. These alloys were the most susceptible to corrosion of all the aluminum alloys included in the test. x 1.

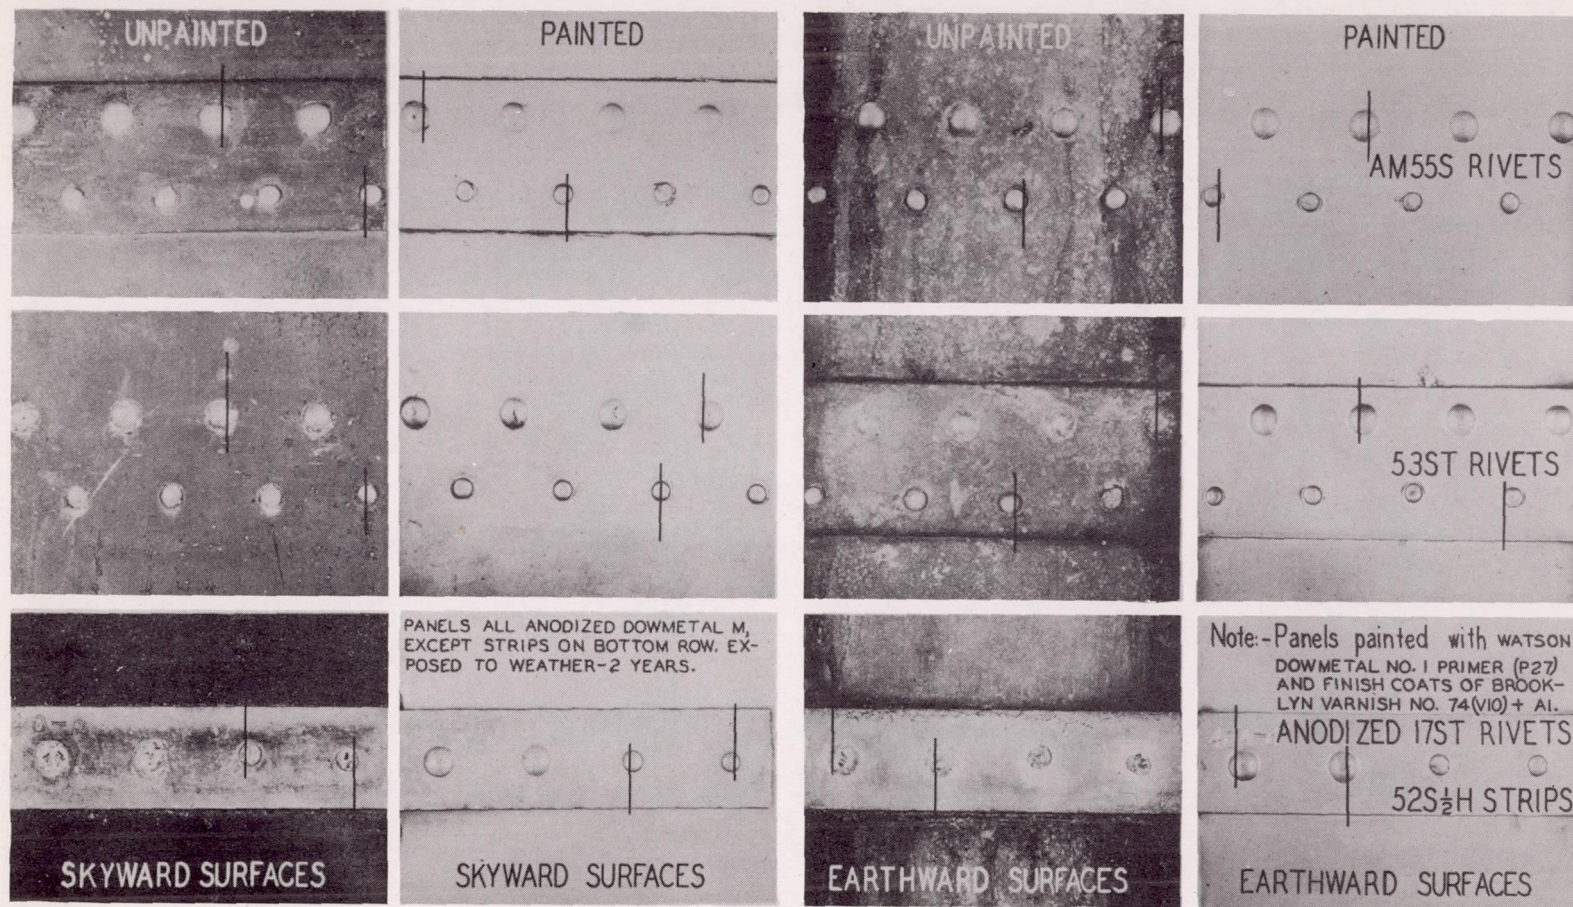
The anodized 17ST rivets on unpainted panels, after 2 years of exposure to the weather, were in advanced stages of disintegration (fig. 7), while the 53ST rivets were also severely attacked. Both were much worse attacked than after 1 year of exposure. The AM55S rivets, however, continued to exhibit relatively little attack. The Dowmetal M sheets were discolored brown on the skyward surfaces and were partly covered with a thin nonuniform grayish-white film of corrosion product on the earthward surfaces. Microscopic examinations (fig. 8) revealed a few pits 0.001 inch deep on the AM55S rivets, but the 53ST rivets had several pits 0.003 inch deep. Numerous pits from 0.002 to 0.008 inch deep were found on the Dowmetal M sheet, and its edges were rounded off by corrosion. Relatively little corrosion occurred on the Dowmetal M surfaces which were in contact with the Neoprene tape.

Figure 7.- Rivets on Dowmetal M panels exposed to the weather. The AM 55S rivets were very much less attacked than the 53ST or anodized 17ST rivets. The paint coating, however, protected both the rivets and the sheet from attack. x 1/2 (8).

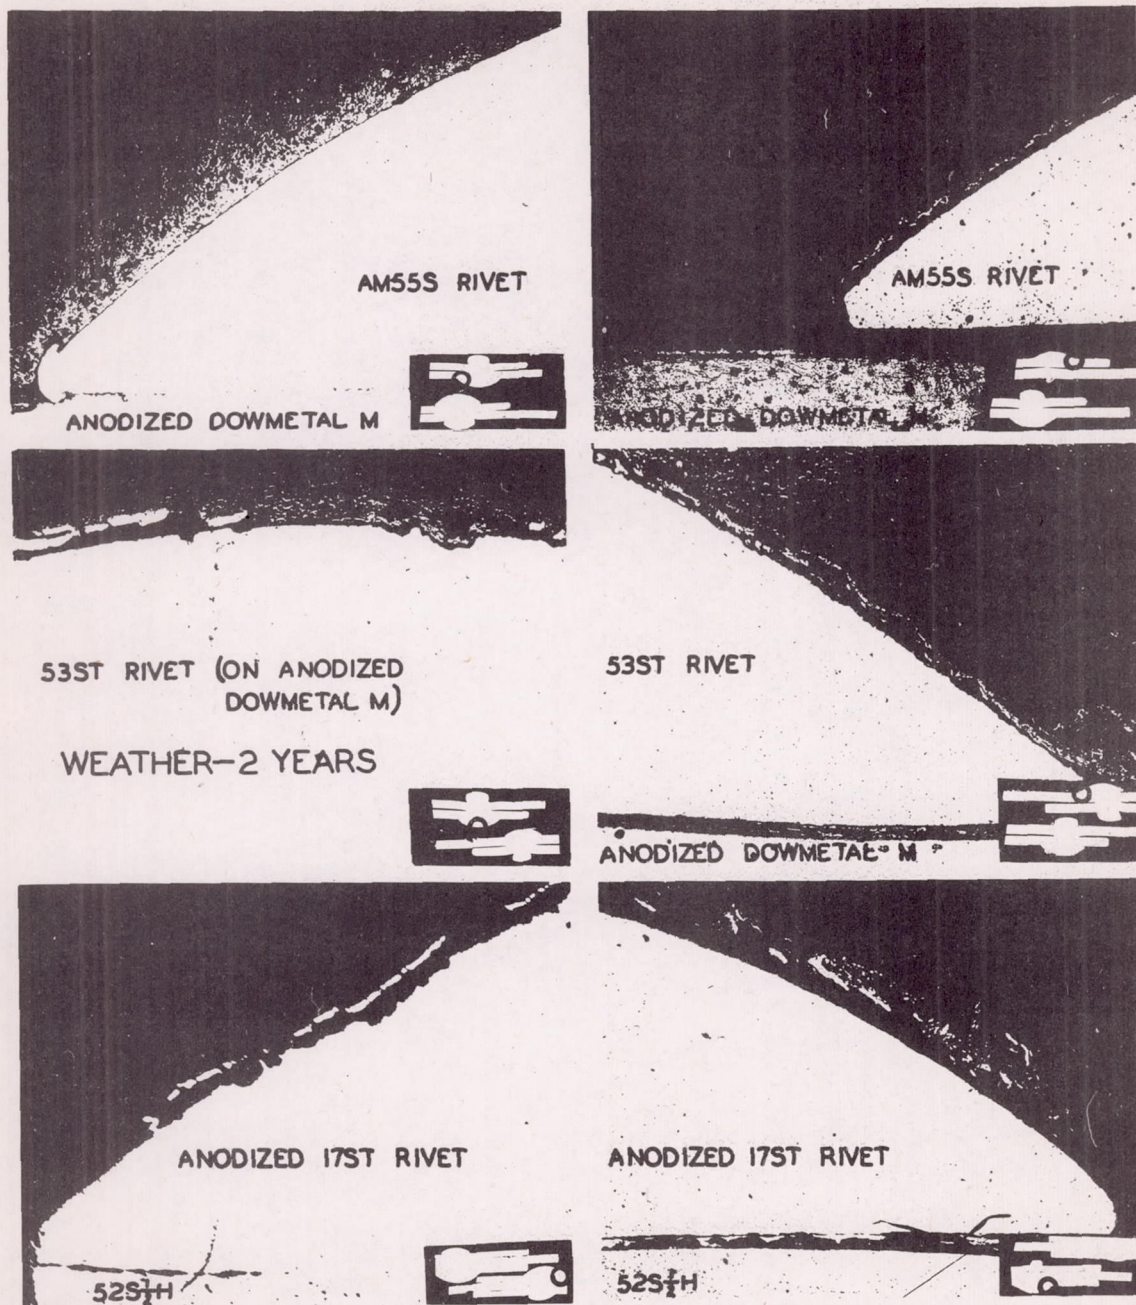
Figure 8.- Corrosion on rivets used for joining Dowmetal M sheets. Attack was least on the unanodized AM55S, intermediate on the 53ST, and most on the anodized 17ST rivets on unpainted panels. None of the rivets on painted panels were corroded. Micrographs, x 40; cross-sections, x 1.

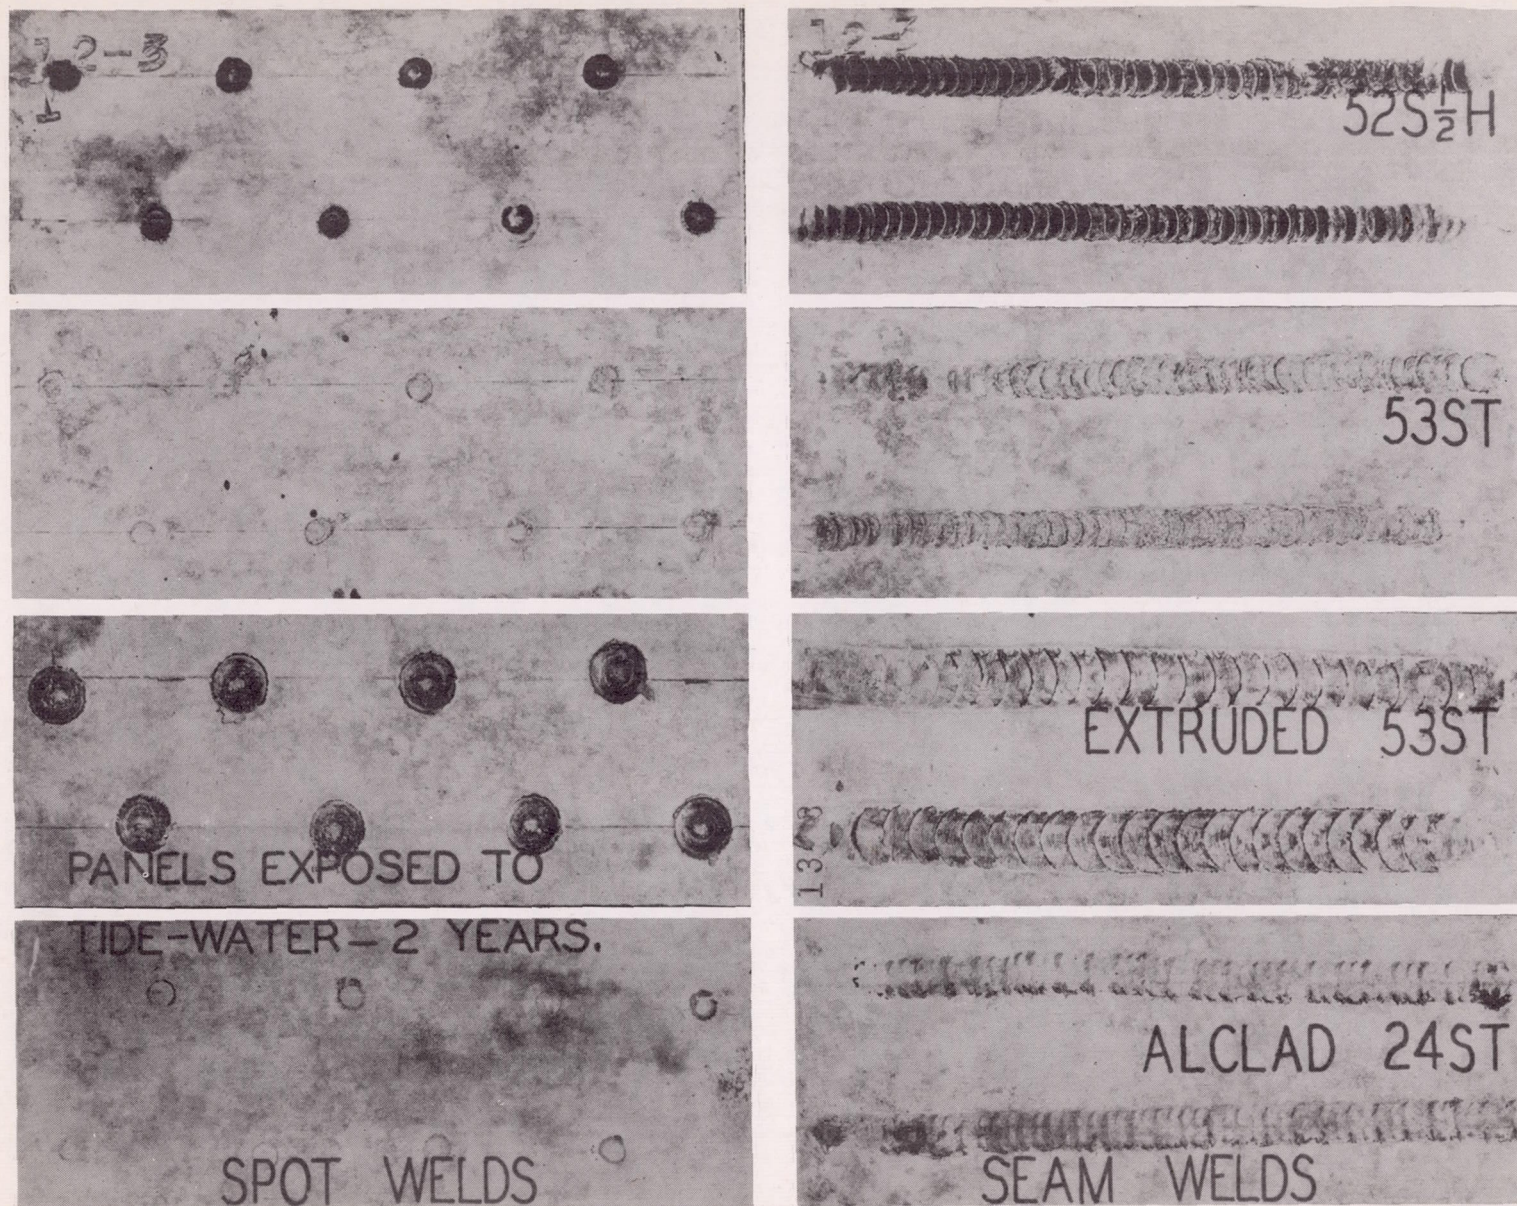
None of the welded panels exhibited much corrosion after 2 years of exposure to tidewater (fig. 9). This result indicates that either the metal on the surfaces of the welds had potentials approximately equivalent to that of the remainder of their respective panels or else were somewhat cathodic thereto. The microscopic examinations (fig. 10) revealed that corrosion on the welded or unwelded parts of the panels was largely confined to a relatively few small pits, nearly all being less than 0.001 inch deep. On the 53ST and the 52S- $\frac{1}{2}$ H panels a few small areas of intercrystalline corrosion occasionally appeared; a very few had depths of 0.004 inch. The 53ST panels exhibited more attack, however, than the 52S- $\frac{1}{2}$ H panels. The surfaces of welds joining dissimilar alloys were corroded similarly to those joining alloys of the same compositions. The faying surfaces, which were in metallic contact, were relatively free from corrosion.

Figure 9.- Welded aluminum alloy panels remained practically unattacked after 2 years of exposure to tidewater. The dark colorations on some of the welds were caused by the copper electrodes used for welding. x 1 (10).

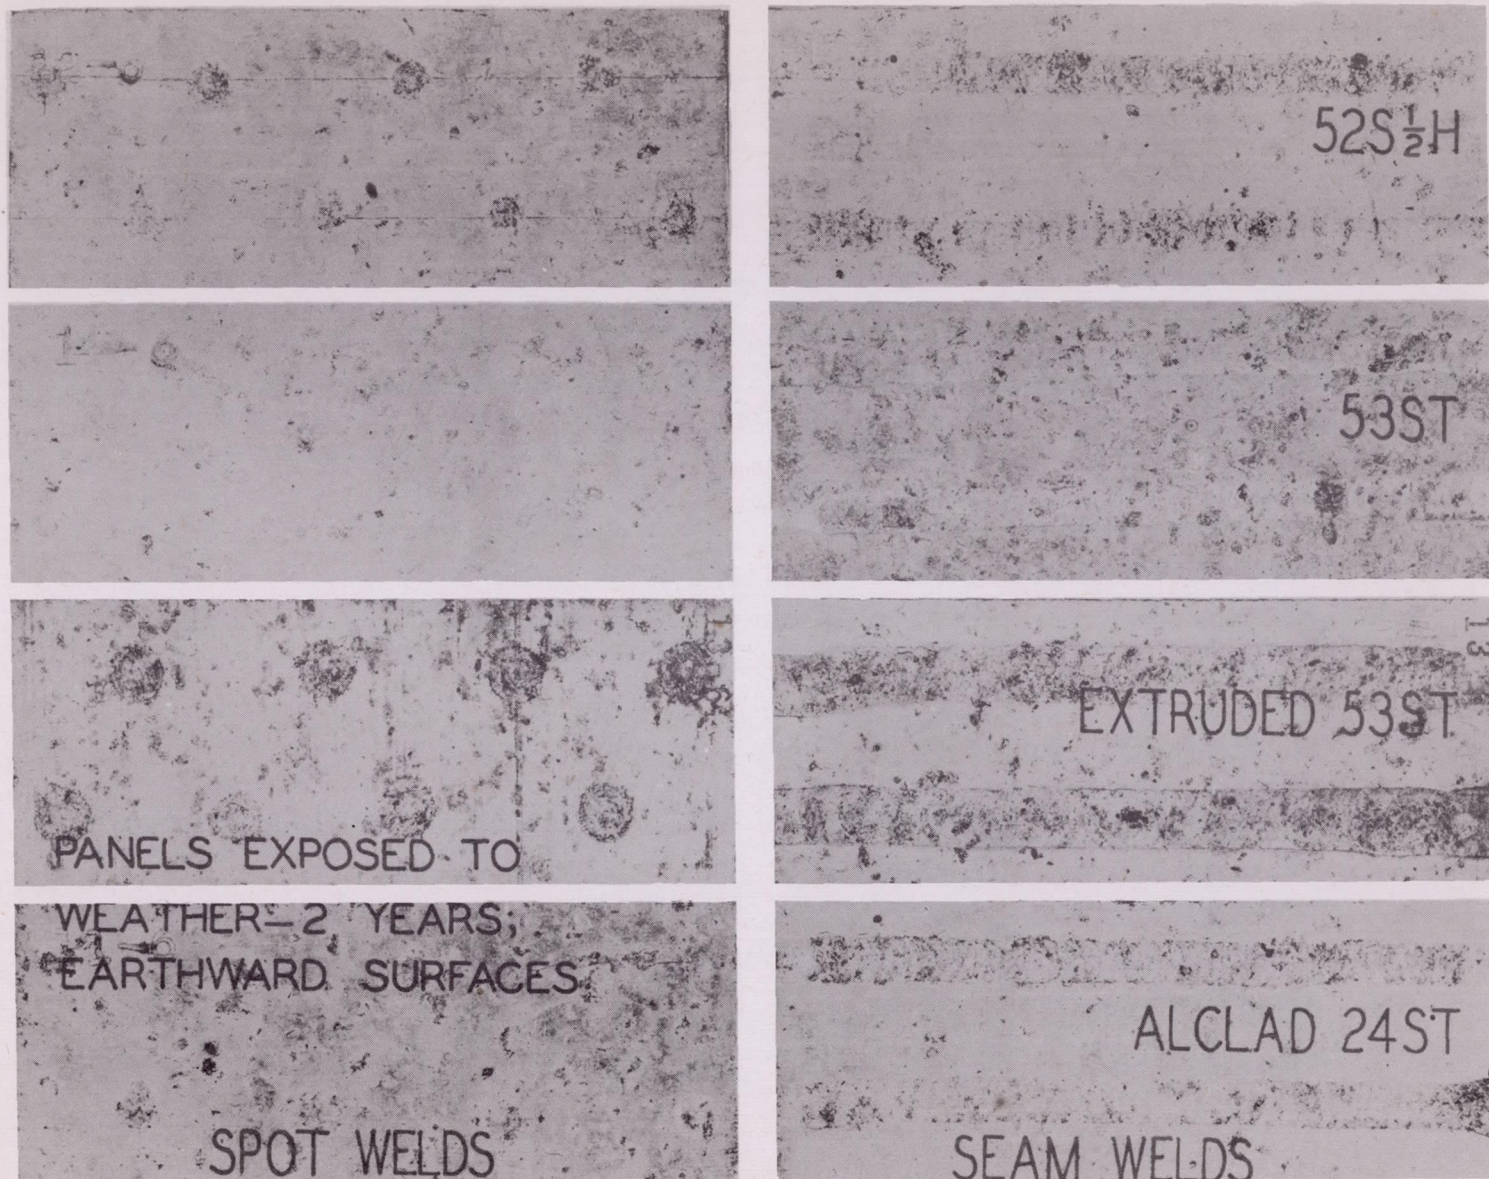
The panels exposed to the weather for 2 years (fig. 11) were much more corroded, especially on the welds, than those in tidewater. In general, the attack was somewhat worse on the earthward surfaces than on the skyward surfaces. The seam welds were more corroded than the spot welds, while the gas welds exhibited but little attack.

Figure 11.- Welded aluminum-alloy panels exposed to the weather were more corroded than those exposed to tidewater, especially at the welds. x 1 (11).

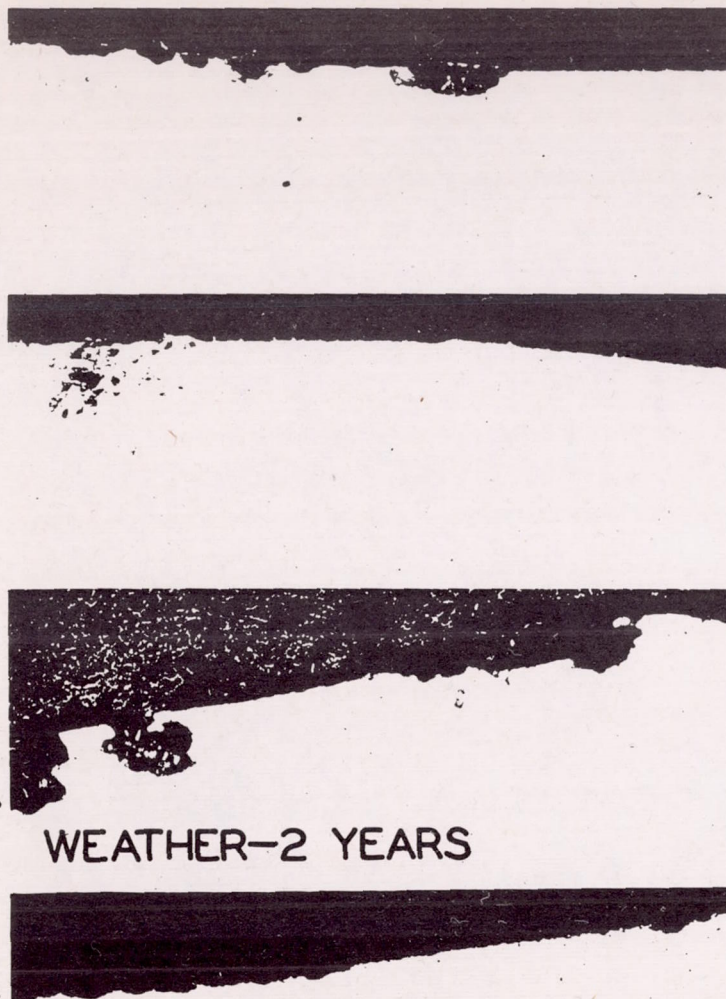
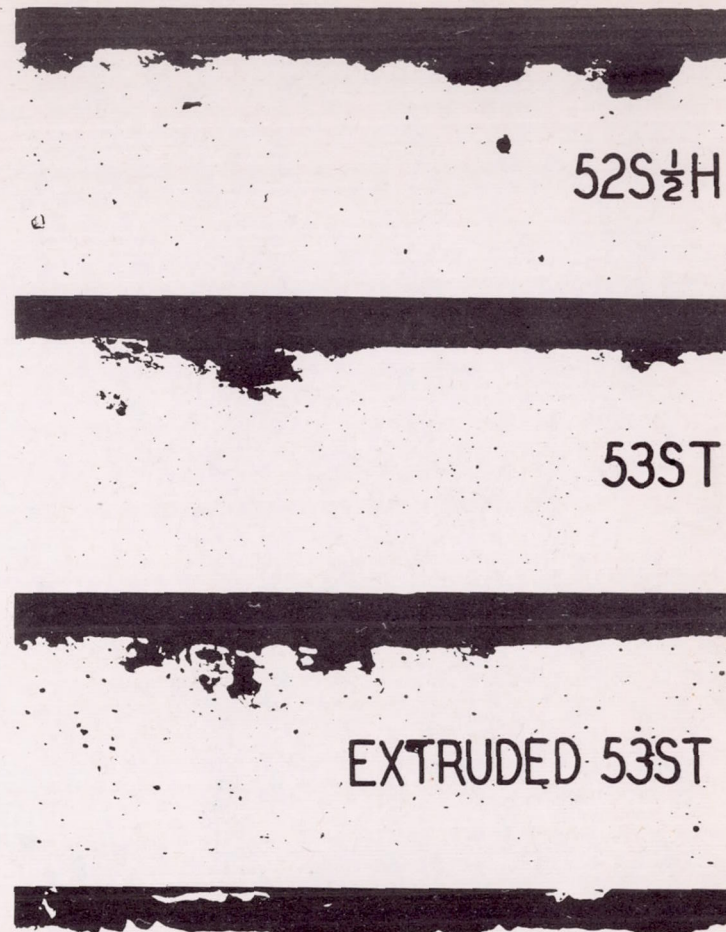
The microscopic examinations (figs. 12 and 13) of the spot welds disclosed many pits (0.001 and 0.002 in.) on the Alclad 24ST panels, but in no case was penetration of the aluminum protective coating found. On 52S- $\frac{1}{2}$ H welds numerous pits were found associated with some intercrystalline attack, generally 0.002 inch deep, but occasionally 0.006 inch. The welds on the sheet and extrusions of 53ST alloy were attacked similarly to those on 52S- $\frac{1}{2}$ H but intercrystalline attack was more in evidence; and occasionally pit depths of 0.010 inch were noted. Little attack occurred at the faying surfaces, but some pits 0.005 inch deep were detected on the 53ST materials.

On the seam welds the attack was somewhat more severe. The aluminum coating on the Alclad 24ST panels was penetrated in some instances and the attack reached a depth of 0.004 inch, as it did also on the 52S- $\frac{1}{2}$ H welds. Seam welds on the 53ST alloys were occasionally corroded to depths from 0.007 to 0.012 inch. The gas welds proper showed but slight attack. At the junction of the weld metal with the unwelded parts of the sheets, however, corrosion sometimes attained a depth approximating 0.004 inch.

Figure 12.- Microscopic examination of welds on aluminum-alloy panels exposed to the weather revealed considerable corrosion of greater depth than occurred on unwelded portions. Seam welds were the most severely attacked. Corrosion on welds on Alclad 24ST was

shallower than on the other alloys but penetrated the protective aluminum coating in some instances. x 50.

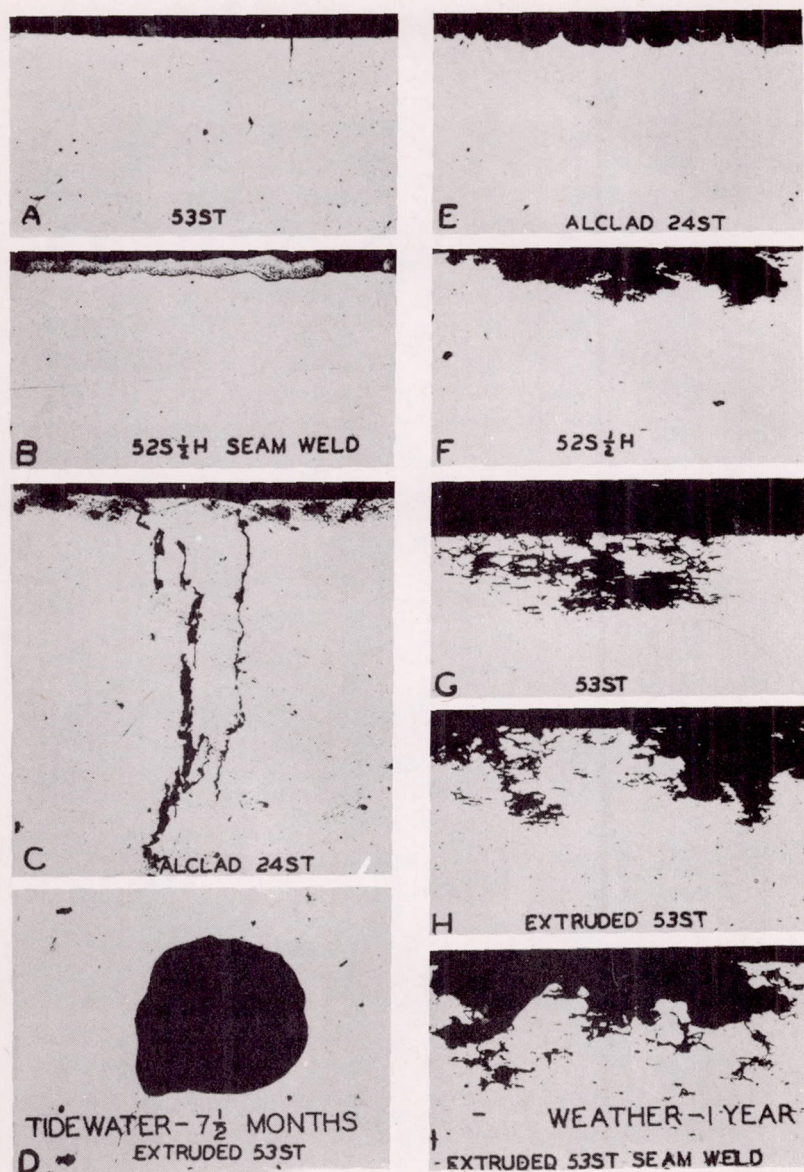
The seam welds were uniformly sound, but cracks occurred on some of the Alclad 24ST spot welds (fig. 13); whereas very small cavities, 0.001 inch in diameter, were present on a few of the 52S- $\frac{1}{2}$ H welds and cavities as wide as 0.010 inch were found in several of the welds on extruded 53ST panels. Numerous cavities, ranging from 0.005 to 0.010 inch in diameter, were found in the gas welds.

Figure 13.- Photomicrographs of welds on aluminum-alloy panels exposed to weather or to tidewater. Spot welds are pictured, unless otherwise noted. A - Formative stage of intercrystalline corrosion. B - Coating on weld, perhaps resulting from reaction with the electrode. C - Cracks present in some of the spot welds in this alloy. D - Cavity, representative of those of average size found in some spot or gas welds. E - Pitting, though general, had not penetrated the aluminum protective coating during the first year. F - Traces of intercrystalline attack were occasionally associated with pits on the 52S- $\frac{1}{2}$ H alloy. G - Intercrystalline corrosion on an area of the sheet remote from a weld. H and I - Intercrystalline corrosion on welds. x 60.

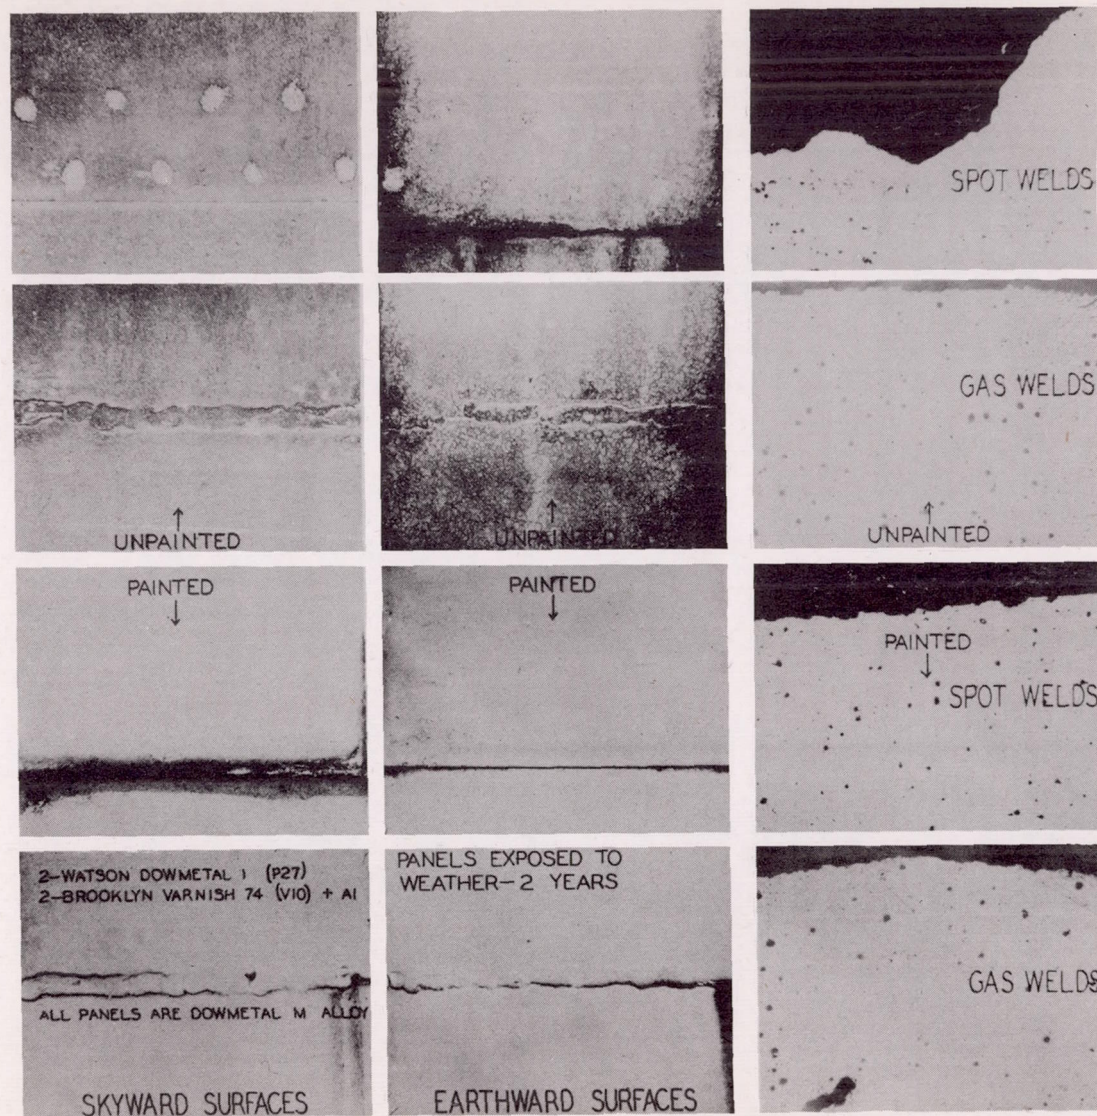
Fig. 14

Figure 14.- Surface appearance and cross section of Dowmetal M panels with spot and gas welds exposed to the weather. The spot welds were susceptible to corrosion owing to contaminations of copper derived from the electrodes used in welding. The gas welds were quite resistant to corrosion and were attacked, in general, less than the rest of the panel. Painted panels were relatively free from corrosion. Micrographs, x 1/2; photomicrographs, x 25. (12).

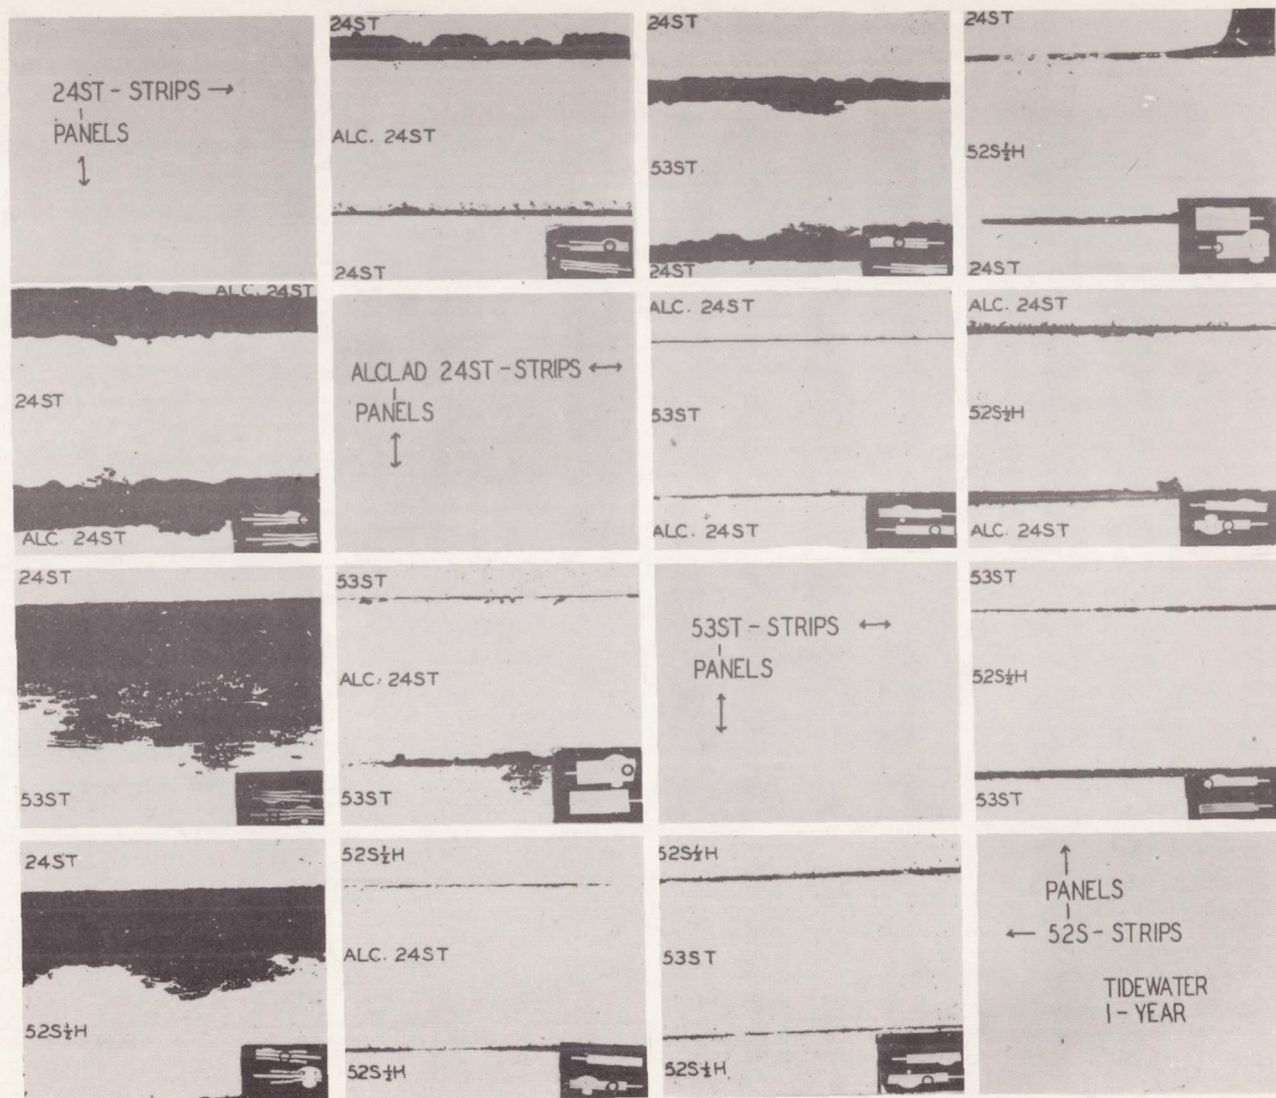
Figure 15.- Cross sections showing aluminum alloys exposed to tidewater in contact with each other. Note that the Al-clad 24ST, 52S- $\frac{1}{2}$ H, and 53ST were anodic to 24ST alloy and were especially severely attacked when 24ST was the main panel. The lack of proximity of strips to the panels, in some instances, is a criterion of the amount of accumulated corrosion products at the faying surfaces which forced the sheets to separate. Photomicrographs, x 25; smaller cross section, x 1/2. (13 and 14).

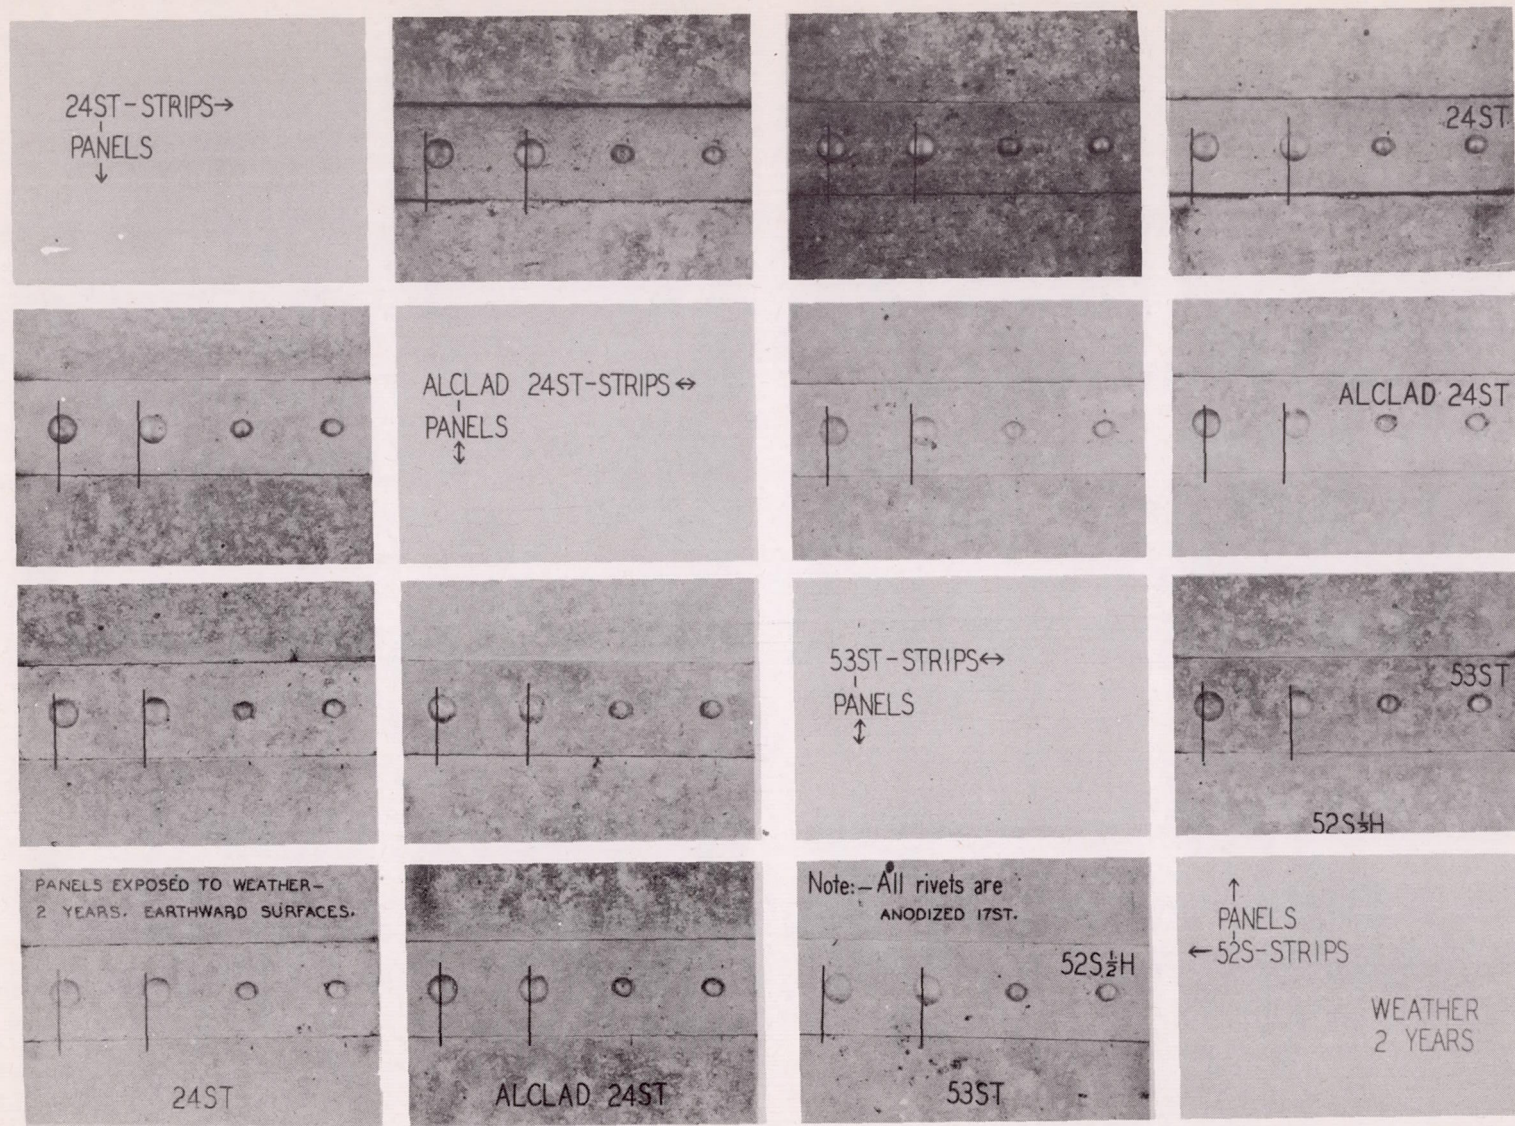
The surface appearance of the panels exposed for 2 years to the weather (fig. 16) indicates that, though corrosion products in some instances accumulated along the edges of and under the 1- by 4-inch strips, the quantities of such products were usually less than the quantities on the panels exposed to tidewater. The results of the microscopic examinations (fig. 17 and table II) are included for comparison with the panels exposed to tidewater.

Figure 16.— Surface appearance of aluminum alloys exposed to the weather in contact with each other. Accumulations of corrosion products at the faying surfaces were usually much less than when the same alloys were exposed to tidewater or were in contact with more dissimilar metals. $\times 1/2$ (13 & 14)
